**[Docket No. FAA-2022-0459; Project Identifier MCAI-2021-00266-E; Amendment 39-22102; AD 2022-13-16]**

**Airworthiness Directives; GE Aviation Czech s.r.o. (Type Certificate Previously held by WALTER Engines a.s., Walter a.s., and MOTORLET a.s.) Turboprop Engines**

**ACTION:** Final rule.

**2022-13-16 GE Aviation Czech s.r.o (Type Certificate previously held by WALTER Engines a.s., Walter a.s., and MOTORLET a.s.): Amendment 39-22102; Docket No. FAA-2022-0459; Project Identifier MCAI-2021-00266-E.**

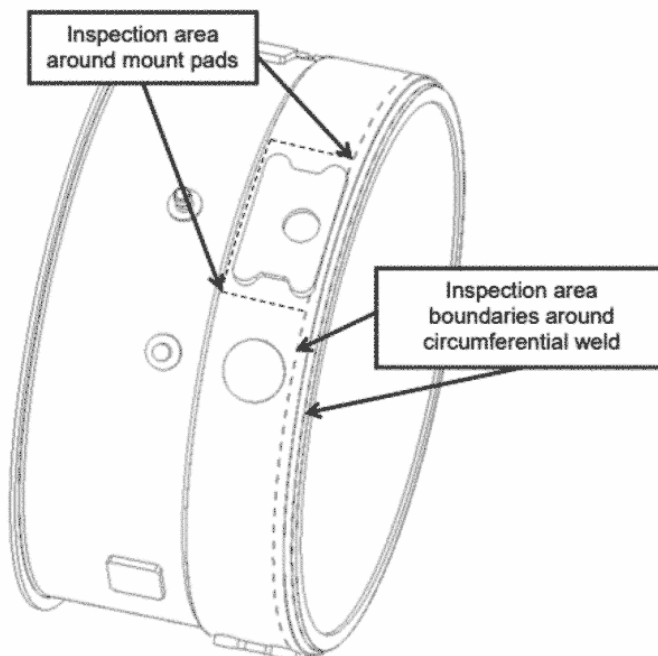
Figure 1. Centrifugal Compressor Case

This AD was prompted by the manufacturer revising the airworthiness limitations section (ALS) of the existing engine maintenance manual (EMM) to include a visual inspection of the centrifugal compressor case for cracks. The FAA is issuing this AD to prevent failure of the centrifugal compressor case. The unsafe condition, if not addressed, could result in failure of the centrifugal compressor case, engine separation, and loss of the airplane.

Do a visual inspection of the compressor case in the specified areas, shown in Figure 1, for every  $100 \pm 10$  Flight Hours. Use magnifying lens 10x for inspection. No visible cracks are allowed.

(1) Within 90 days after the effective date of this AD, revise the ALS of the existing EMM by incorporating Figure 1 to paragraph (g)(1) of this AD.
